APPENDIX E.3.3

SIDE CHANNEL ENHANCEMENT INVESTIGATION

To: Jeremy Pratt
CC: Jean Baldrige and Woody Trihey – ENTRIX
John Arterburn and Keith Kistler – CCT
Dan Boettger and Nick Christoph – OKPUD
From: Greg Reub – ENVIRON
Date: 7-8-08
Re: Enloe Hydroelectric Project – Review Draft – Side Channel Enhancement Investigation

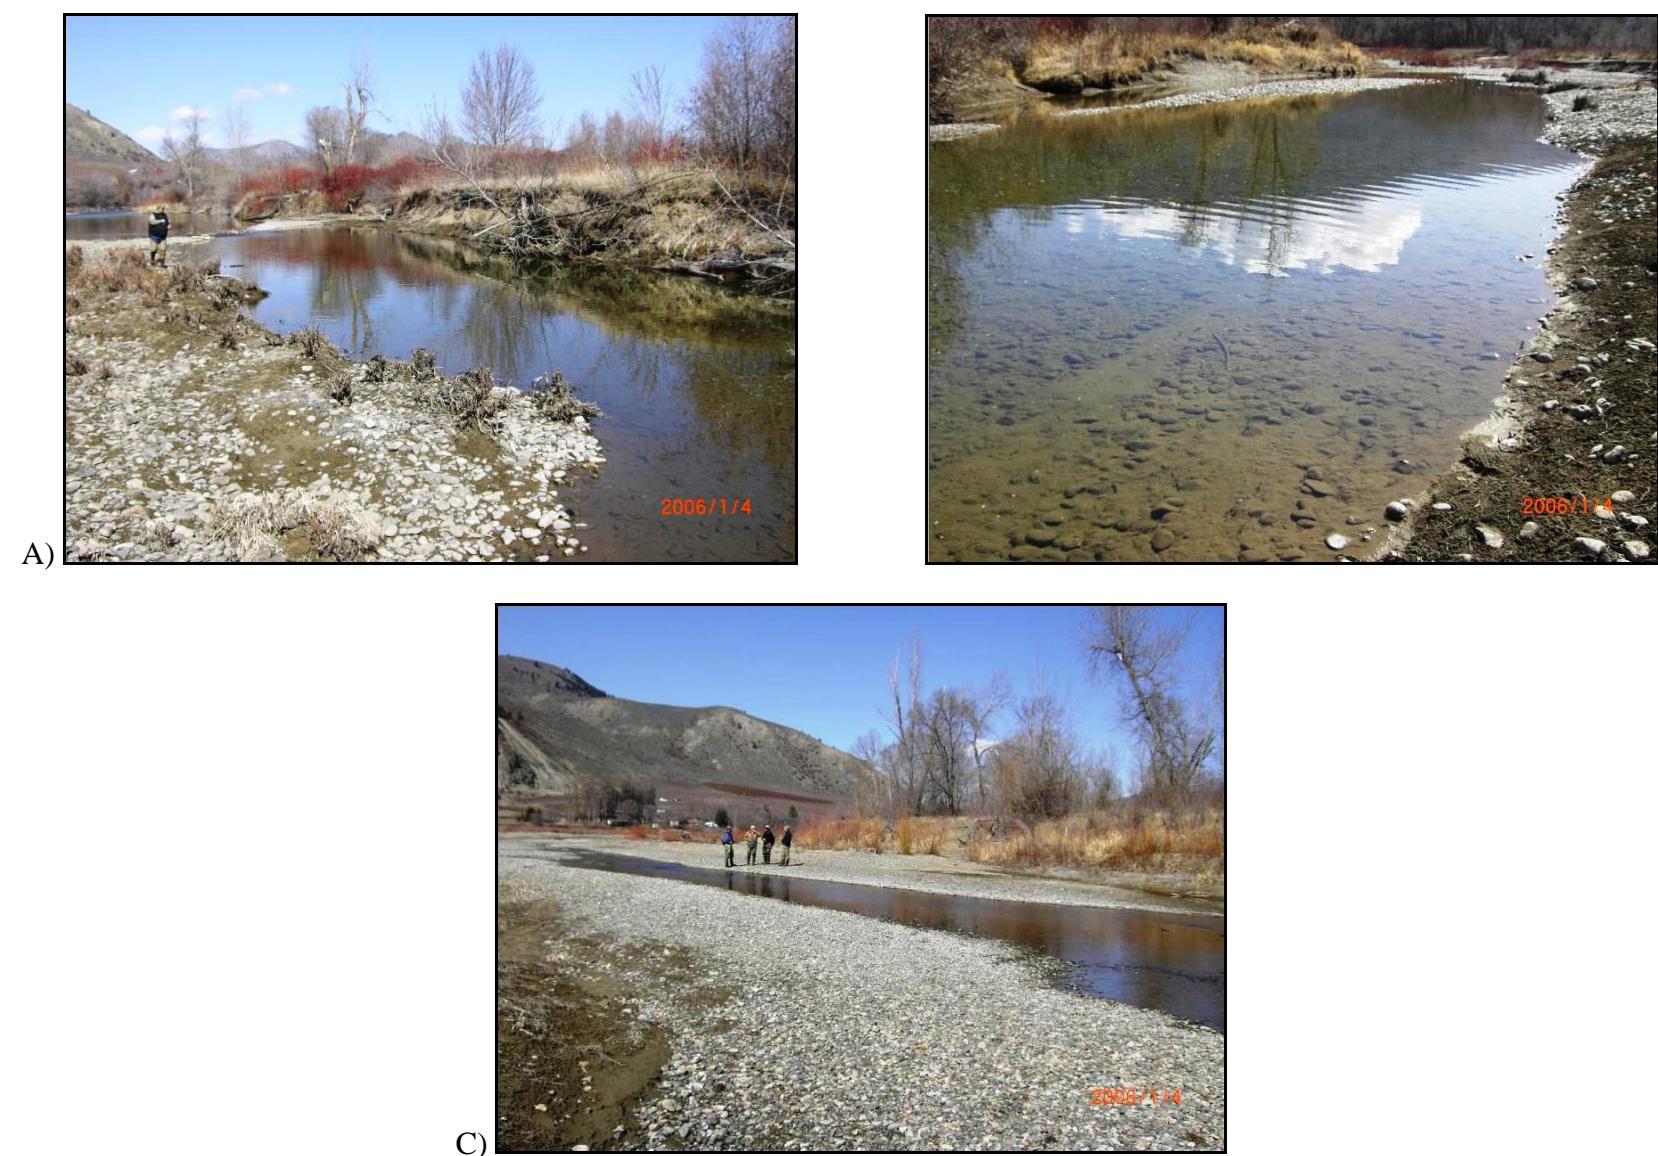
Figure 1. Reference side channel illustrating good rearing habitat in the upstream portion – looking upstream (A), and middle portion of the channel - looking downstream (B), and spawning habitat in the downstream portion of the channel – looking downstream (C).

The upper and middle sections of the reference site illustrated good rearing habitat as indicated by diverse geomorphology, deeper pools and large woody debris (LWD) on and near the bank of the channel. Although this was a relatively large side channel, the entrance of the side channel was oriented away from the main stem flow and appeared to be stable. The entrance appeared to provide good protection from high flows. Gravel substrate separating the pools were likely good production areas of aquatic invertebrates and the bank vegetation likely contributes terrestrial invertebrates to the site. The lower section of the reach was excellent steelhead spawning habitat as illustrated by the large amounts of appropriately sized spawning gravels. Flows during steelhead spawning are at least six inches to a foot deeper than shown in the photographs, covering much of the

gravel present. An important aspect of this site was that it appears to be a stream reach that gains water with distance downstream (a gaining reach). During the site visit, it was obvious that there was more water leaving the site than entering the site. This was due to water flowing under the streambed at the top of the site becoming surface water as it traveled downstream. Since water temperature is known to be a major limiting factor in salmon and steelhead production, the cooler subsurface water entering the surface environment is important. Because the water entering the site is from below the streambed, it is cooler and an important factor in quality rearing habitat, especially during hot summer days.

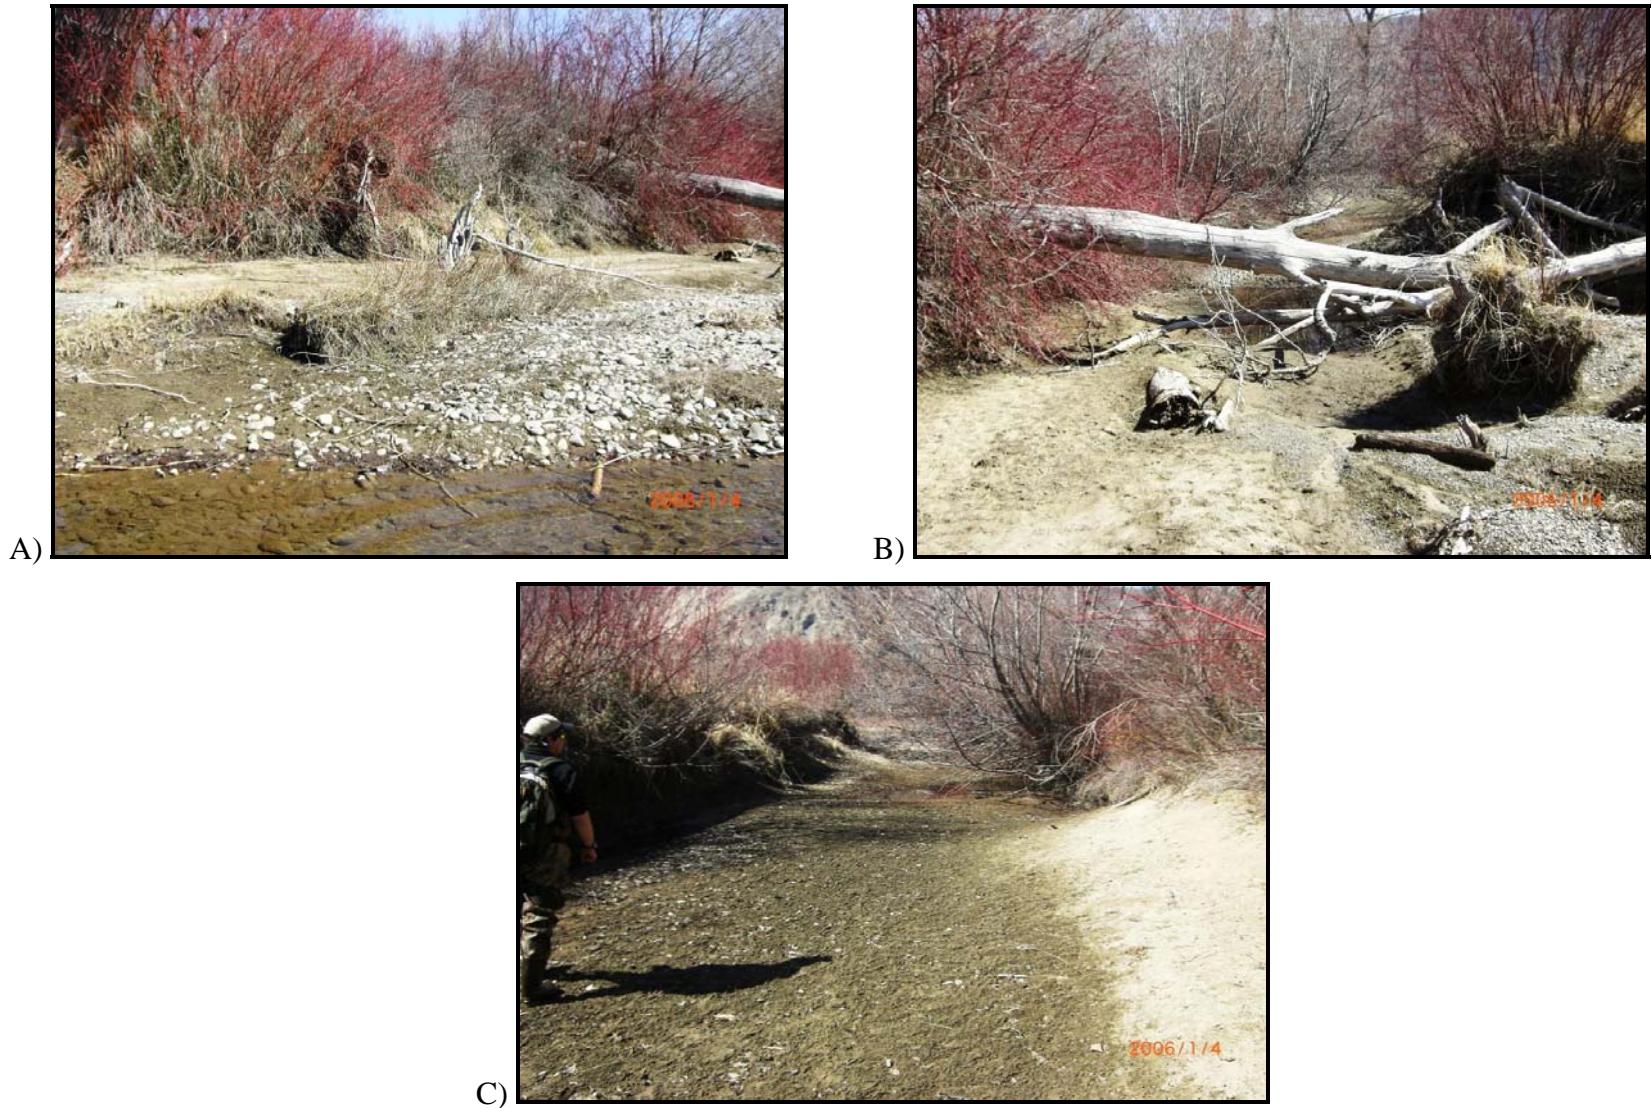
Figure 3. Potential channel enhancement Site 1 illustrating the channel from the upstream end with the Similkameen River in the foreground (A), the upstream end – looking downstream, (B) and the middle to downstream portion of the channel – looking downstream (C).

Site 1 was in the Similkameen River as shown in Figure 2 and described in Table 1. The channel was approximately 250 to 300 feet in length and probably averaged 20 to 30 feet in width (Figure 3). The site scored moderate for potential to affect existing habitat because it was close to the reference site described above (Table 2). The site scored relatively high in the other categories. It seemed evident that the channel occasionally carried water during high flow events but was generally protected from direct and damaging flows of the mainstem. Water was present in the head of the channel and shallow ground water or surface water is likely easy to get to the site. Substrates were generally sand and silt/organics with areas of gravel, although it appeared gravel was present below the finer substrates in much of the site. Other considerations included easy access to the main channel by fish and proximity to spawning habitat. This site received the highest score (along with site 2) with 20 points.

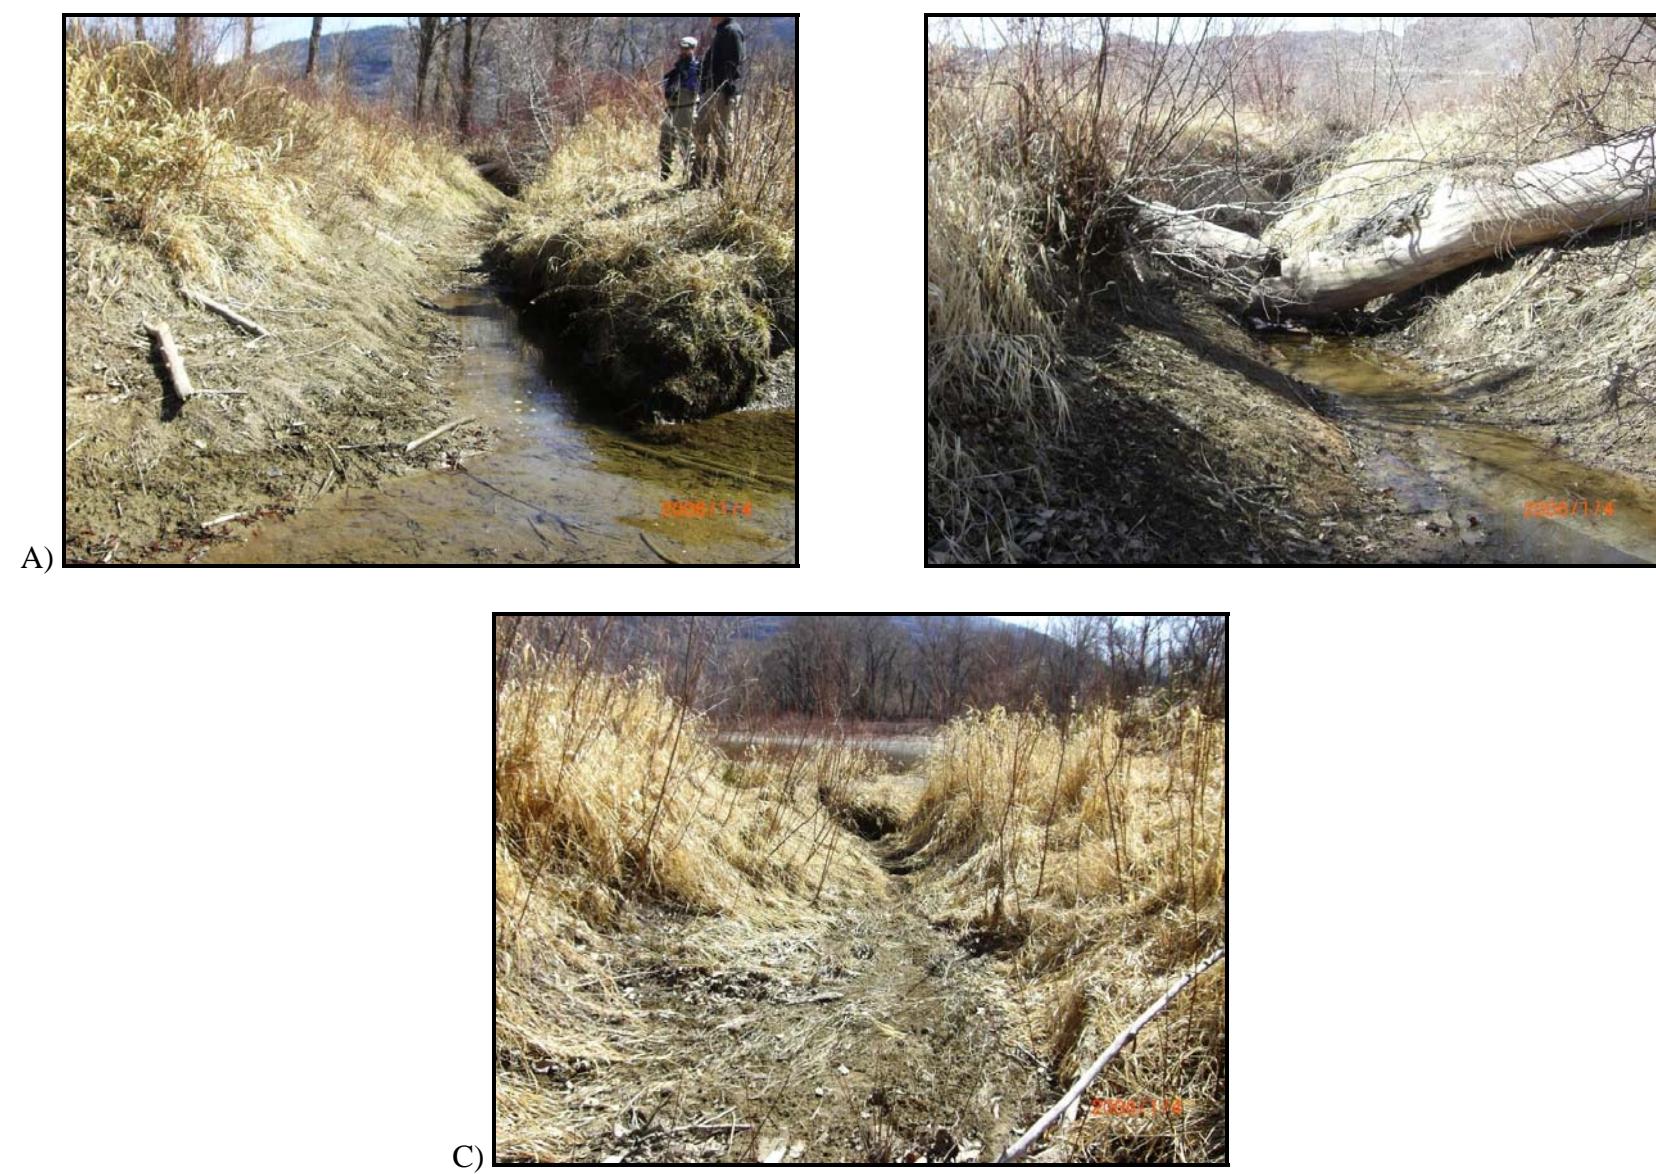
Figure 4. Potential channel enhancement Site 2 illustrating the channel from the upstream end – looking downstream (A), the middle part of the channel – looking downstream (b) and downstream portion of the channel – looking downstream (C).

Site 2 was in the Similkameen River as shown in Figure 2 and described in Table 1. The channel was over 600 feet in length and probably averaged 10 to 20 feet in width (Figure 4). This site scored medium for potential to affect existing habitat, like site 1, because it was close to the reference site described above (Table 2). The site scored relatively high in the other categories. The channel only carries water during discharges above 1,000 CFS on the Similkameen River. A concern included the need to design the channel so that fish would not become entrapped in the channel during low flow, due to the flat gradient and long length of the channel. It was well protected from direct and damaging flows of the mainstem. Water was generally not present in the channel, although shallow ground water or surface water is likely easy to get to the site. Substrates were sand and silt/organics with few areas of gravel, and it appeared gravel was present a foot or two below the finer substrates in some of the site. Other considerations included easy access to the main channel by fish and proximity to spawning habitat. This site received the highest score (along with site 1) with 20 points.

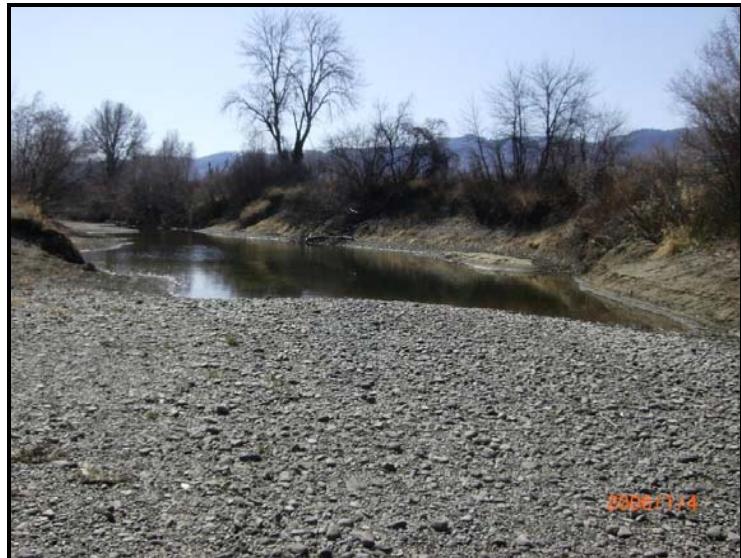
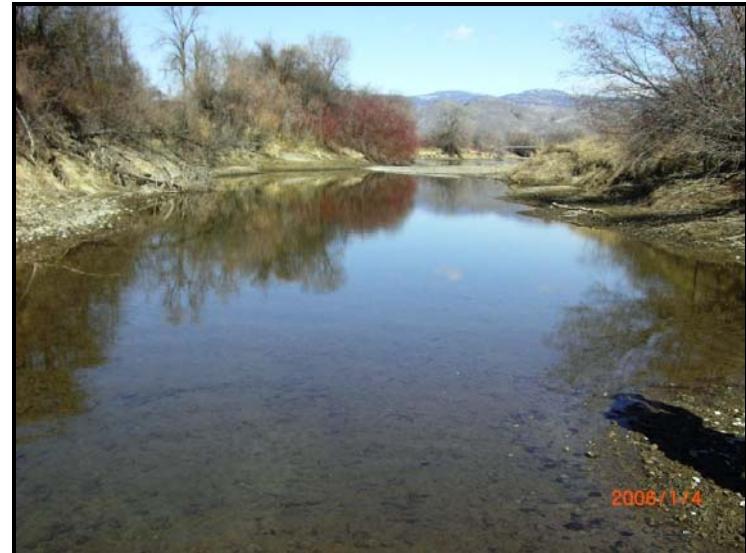
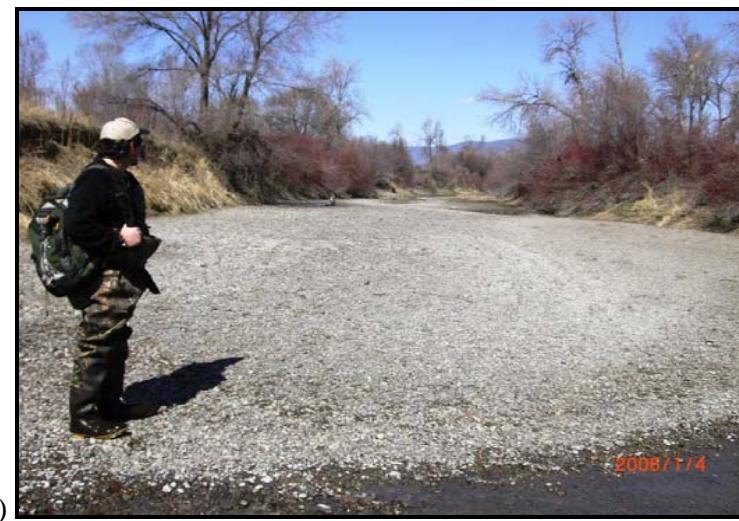
Figure 6. Potential channel enhancement Site 3 illustrating the channel from the upstream end - looking downstream (A), near the middle of the channel – looking upstream (B) and from the downstream end of the channel - looking upstream (C).

Site 3 was in the Okanogan River as shown in Figure 5 and described in Table 1. It is located just downstream at a cross channel that connects the Similkameen and Okanogan Rivers. The channel was about 700 to 800 feet in length and probably averaged 60 to 80 feet in width (Figure 6). The surrounding area and much of this site is heavily used for steelhead spawning. Since the amount of spawning habitat in the site is relatively abundant, a high score for potential to affect existing habitat was given.. It would be beneficial in providing rearing habitat in an area heavily utilized by spawning steelhead. The site scored relatively low in the other categories, except water availability because there are known wells nearby. The channel probably carries a large volume of water during high flow events. There are existing plans to modify a cross channel area just upstream of the site to insure water is delivered into the Okanogan during moderate flows instead of being diverted into the Similkameen. Although shallow ground water is likely available, a significant concern included maintaining a smaller channel that would confine the relatively small amount of water that would be available to affect the high temperatures in summer. The head of the channel would be difficult to protect from direct and damaging high flows from the mainstem. Substrates were dominated by gravel with some cobble and silt/organics. Other considerations included easy access to the main channel by fish and proximity to spawning habitat. The site would likely score higher if it could be combined with other partners/projects and resources on a larger scale restoration. This site received the lowest score with 12 points, mostly related to potential problems in maintaining an enhanced, smaller channel within the site as envisioned in this effort.

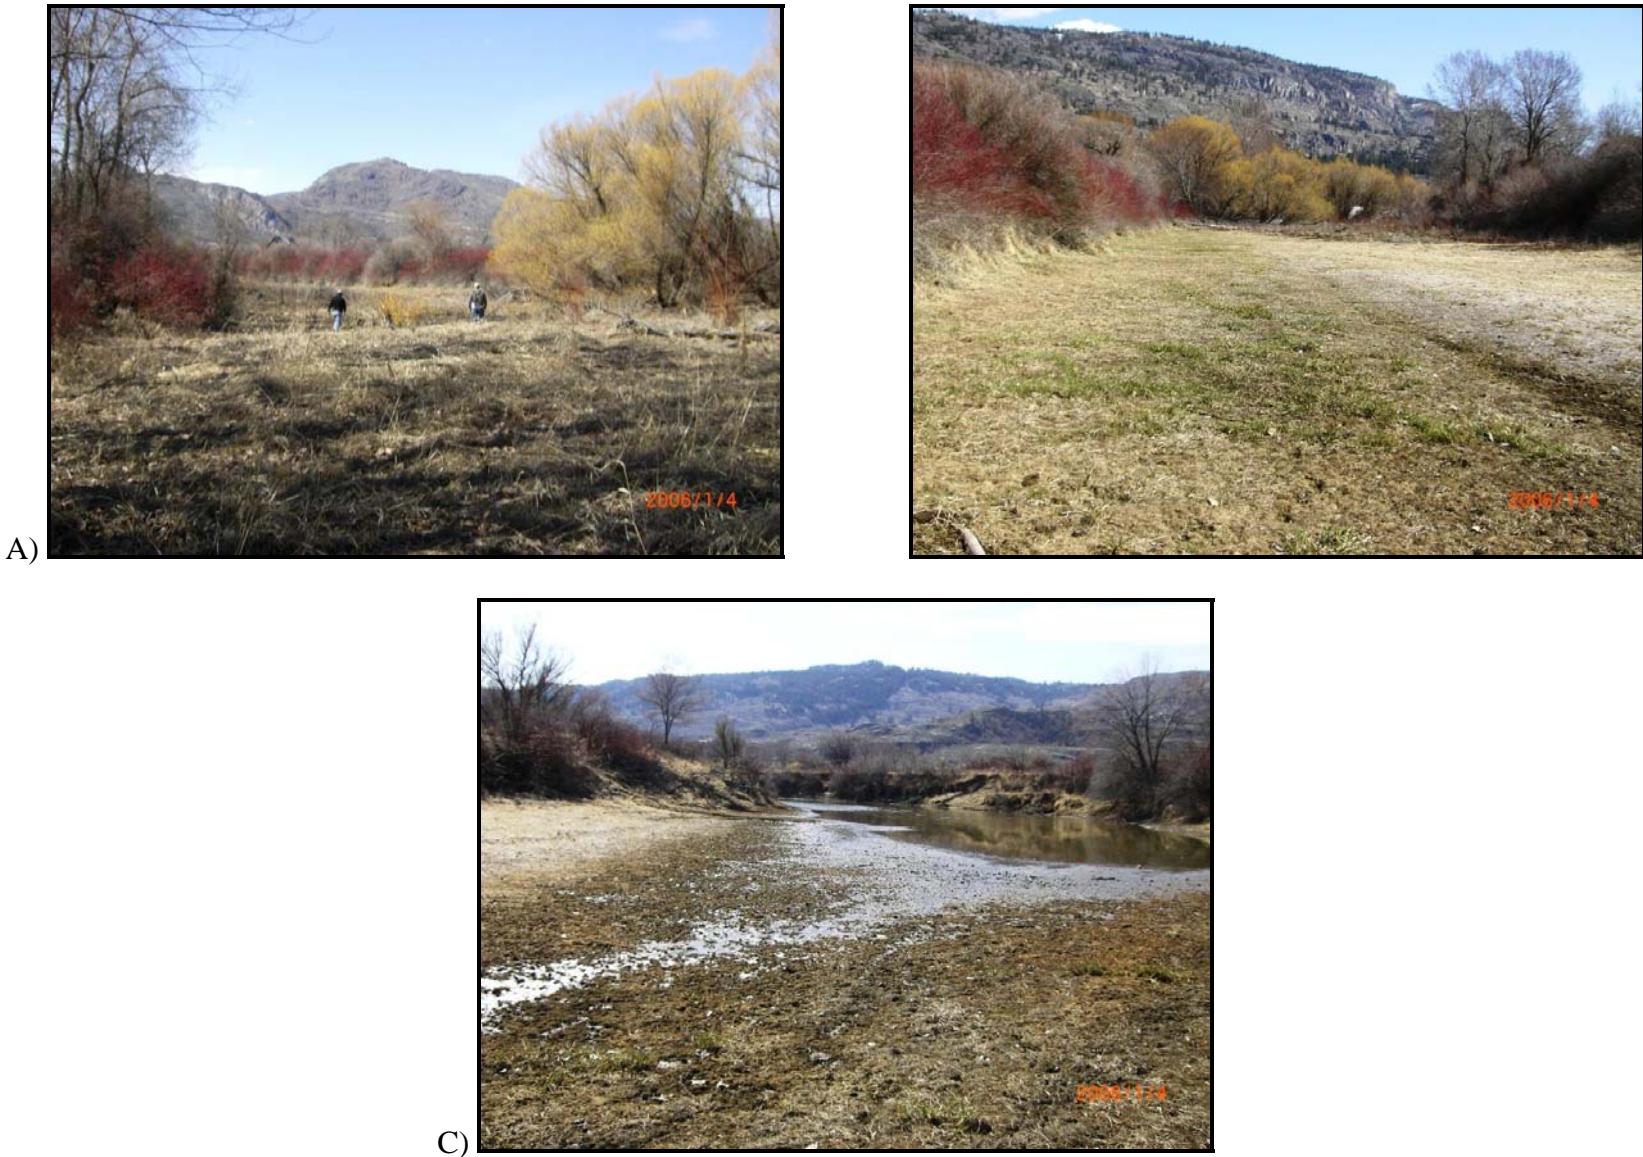
Figure 8. Potential channel enhancement Site 4 illustrating the channel from the upstream end – looking downstream (A), the middle portion of the channel – looking downstream (B) and downstream portion of the channel – looking downstream (C).

Site 4 was an abandoned oxbow of the Okanogan River as shown in Figure 7 and described in Table 1. It was located between the Similkameen and Okanogan Rivers but connected to the Okanogan River. The channel was just less than about 2,000 feet in length and probably averaged around 100 feet in width (Figure 8). The area was not in proximity of any known high value habitat and scored a 5 (Table 2). The site scored relatively low in the other categories except channel protection. Since the site is off of the mainstem and the head of the channel was well above the water level during normal flows, channel protection scored a 4. The channel may carry some amount of water during high flow events and the downstream end of the channel was inundated (backwater) during the low flow period when it was observed. Although shallow ground water is likely available, providing mainstem flows in the upstream end could be challenging. The head of the channel would be protected from direct and damaging flows of the mainstem. Much of the channel was vegetated with grass and shrubs and substrates were dominated by silt and organics. Other considerations included easy access to the main channel by fish and proximity to spawning habitat. This site received a relatively low score of 14 points, mostly related to two potential issues. First, maintaining an enhanced, smaller channel within this large channel area, especially with the potential of a larger amount of existing water to warm the habitat, could be difficult. Second, the existing warm water habitats in the lower portion of the channel would likely support substantial predator populations that have the potential to negate salmonid production increases.

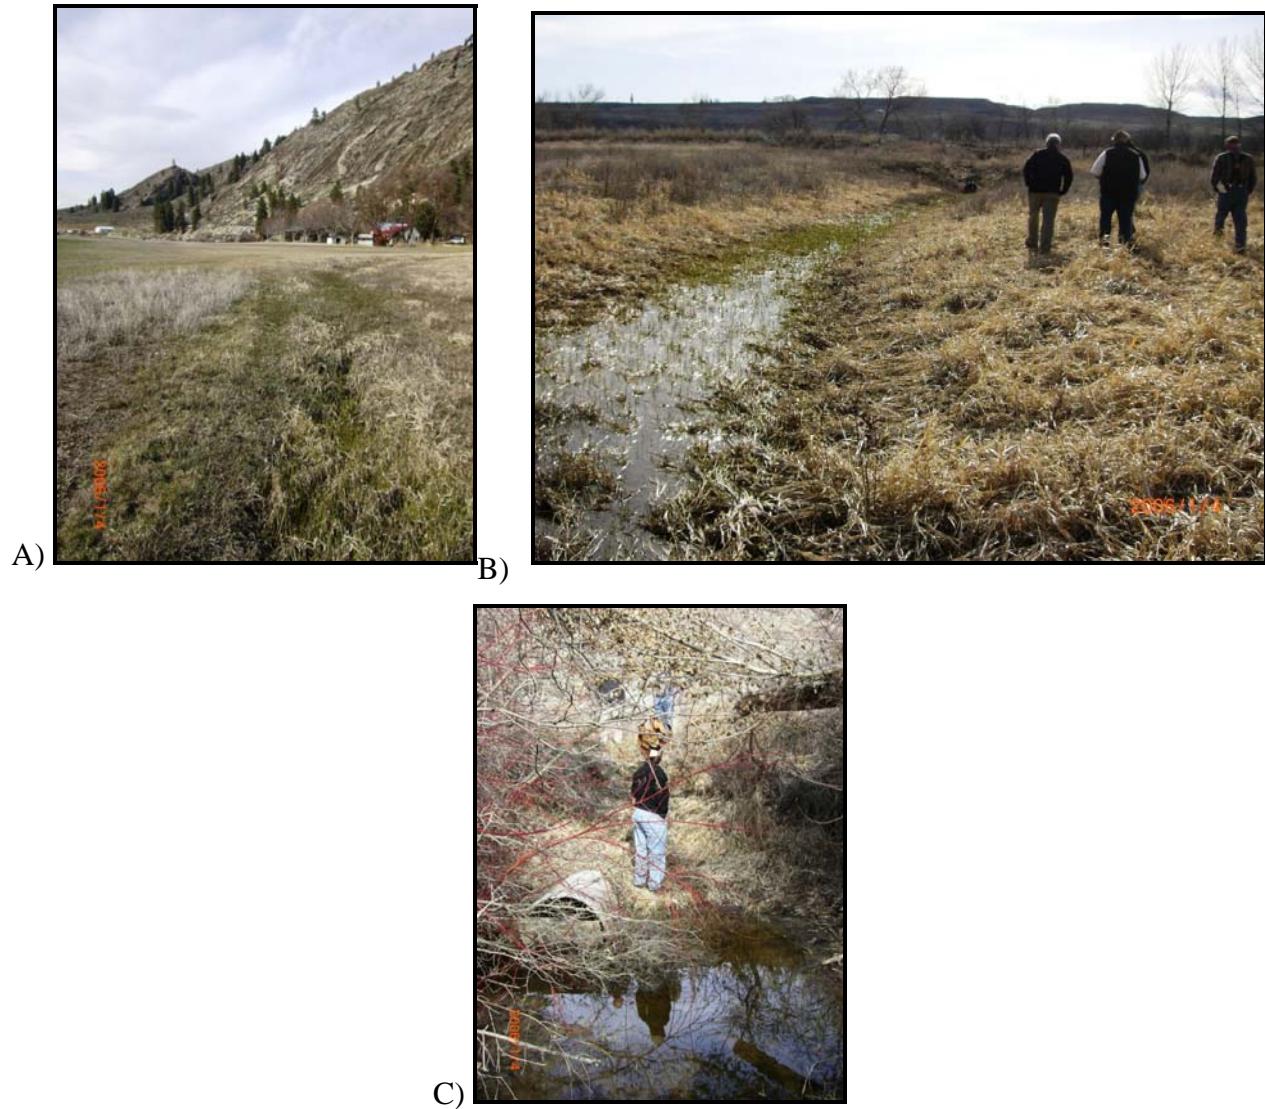
Figure 10. Potential channel enhancement Site 5 illustrating the upstream portion of the channel – looking upstream toward the spring water source (A), the middle to lower channel –looking downstream toward railroad culvert (B), and the confluence with the Okanogan River – looking upstream at culvert just below railroad grade (C).

Site 5 was next to the Okanogan River as shown in Figure 9 and described in Table 1. The channel was around 1,900 feet in length and although the channel was not well defined in the upstream end of the site it probably averaged 5-10 feet in width toward the downstream end where it emptied into the Okanogan River (Figure 10). It is not a side channel but a small drainage located on a cultivated field with water originating from a spring. The water originated from a spring across the road from the buildings seen in Figures 9 and 10. The upper part of the site had little open water but about 1/2 way downstream surface water was observed and it was obviously running near the downstream end where it connected with the Okanogan River. This site scored a 4 (high) for potential to affect existing habitat because, although there is existing habitat nearby in the Okanogan, the potential to affect it would be unlikely (Table 2). The site scored moderate to high in the other categories. The entire channel probably runs with water during rains, only, but there is a well nearby that was thought to have a relatively high production capacity. The channel design would likely include a small deep channel that would function much like a meadow stream. It would depend on spring and ground water and would not require water from the Okanogan mainstem. It was obviously well protected from direct and damaging flows of the mainstem. Substrates were silt and organics typical of a wetland. Other considerations included complicating factors resulting from a culvert going under the railroad with a substantial gradient between the railroad grade and the Okanogan River that is now represented by a perched culvert. This site received the second highest score with 18 points.

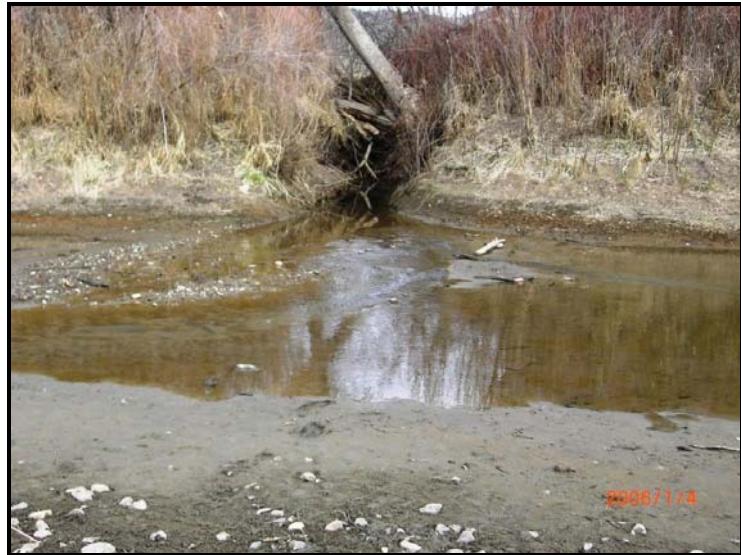
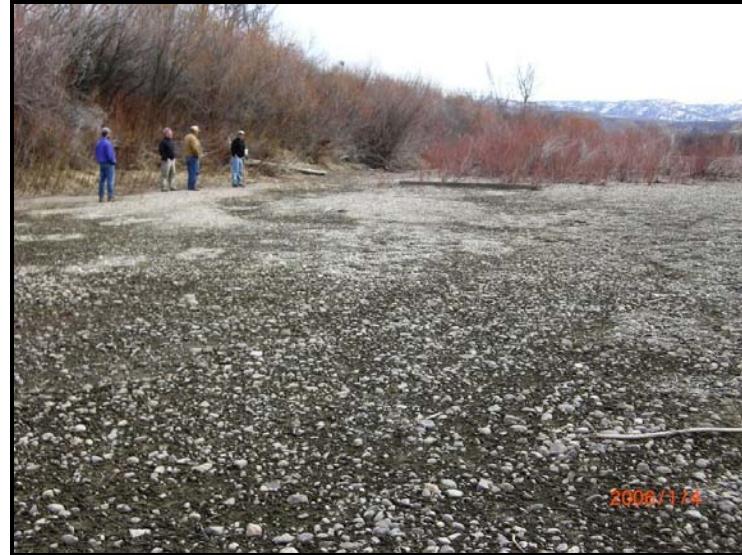
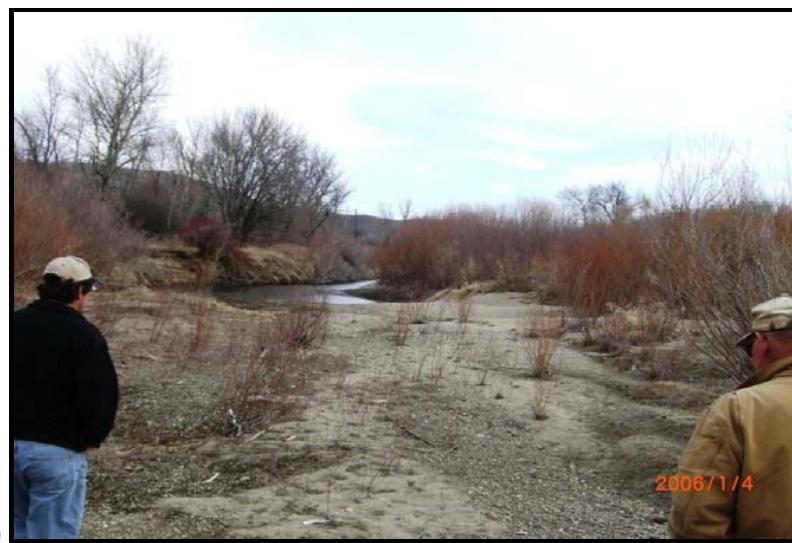
Figure 12. Potential channel enhancement Site 6 illustrating the channel coming from a wetland near Wanucut Creek (A), side channel in upstream and mid channel area (B), and the downstream portion – looking downstream to the wetted side channel (C).

Site 6 was located within a side channel – gravel bar in the Okanogan River. Enhancement measures would also include some channel modification in Wanucut Creek as shown in Figure 11 and described in Table 1. The channel where enhancement could take place was around 400 to 500 feet in length. The Wanucut Creek channel was dry at the time of the visit but appeared to be about 10 feet wide and potentially located in more

than one channel during higher flows. The water from the creek could run into a small constructed channel along the river margin in the side channel and would be protected from mainstem high flows. It would then empty into a larger portion of the side channel that probably always has some water and connection to the mainstem and was wetted during the field visit (Figure 12). The enhanced channel would therefore be constructed from the confluence on Wanucut Creek, downstream about 500 feet to the wetted channel. The site scored low for potential to affect existing habitat because there are potential spawning sites for lamprey in the area (Table 2). The site scored moderate to low in the other categories. Water availability from a groundwater perspective could be complicated due to a sizable housing development that is up gradient with well(s) that may affect the surface water in the area to date. There was a wetland just upstream of Wanucut Creek that had flowing water and had some potential for enhancing the project. Ability to protect the creek portion would be easy but it could be difficult to protect the area in the side channel from flood flows. Substrates in the stream were sand and silt/organics and were generally small and large gravel in the side channel area. Other considerations included easy access to the main channel by fish and proximity to spawning. This site received a relatively low score or 15 points.
